Corrosion of Agricultural Techniques under the Influence of Chemicals

Annotation: Practical determination and analysis of the reasons for the loss of working capacity of agricultural machines working in aggressive agricultural conditions in the machine-tractor park were carried out. Working parts of existing cultivators, seeders, plows, harrows, fertilizing machines, chemical plant protection machines, work in an active corrosion environment and maintain significant mechanical stress. This, in turn, leads to the rapid failure of machines due to corrosion and corrosion-mechanical impact of working bodies.

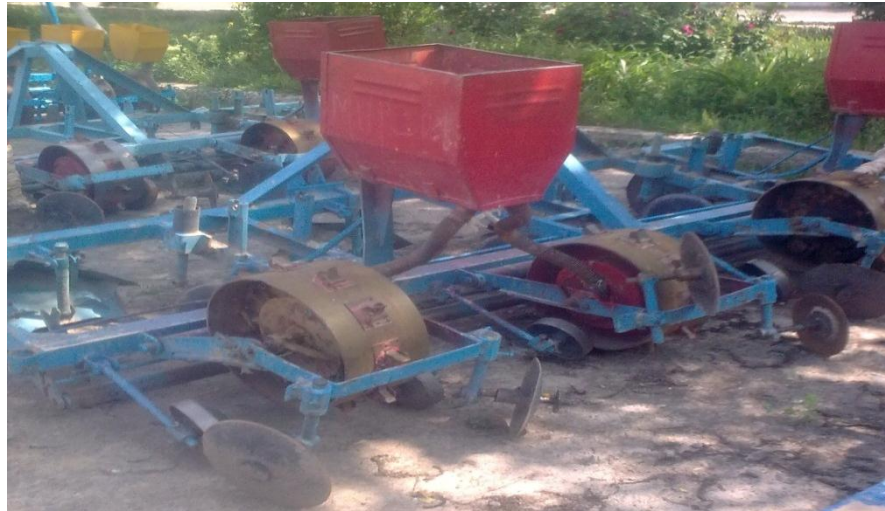
The seeders in the district machine-tractor park are stored in the condition shown in Figure 1. As can be seen from the picture, within 15 days after the seedlings were brought from the field, signs of rust appeared on its details. This is due to the fact that the drill was not washed and cleaned at the required level, was not protected with protective equipment, and was not stored at the required level.

Fig. 1. AN-2M- drill

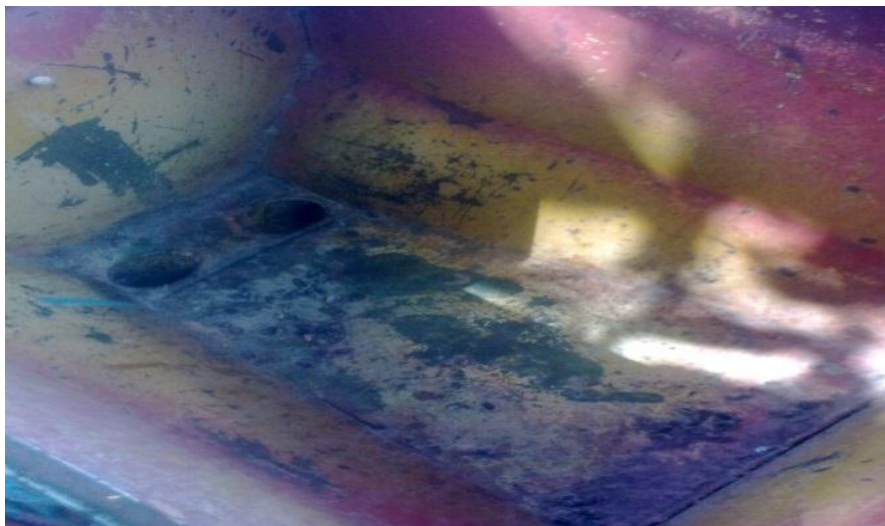
According to the observations, the protective coatings of the seeders' seed hoppers were eroded by 64-55 % of the metal corrosion (see Figure 2-3). This is due to the fact that in the process of preparing MTP seeders for the next season, the rusted surfaces are covered with PF-1155 enamel. During operation, the bunkers are filled with treated seeds. Atmospheric moisture dissolved the herbicide in the seeds that touched the bunker and moistened the protective layer, resulting in rust reaching through the capillary holes of the protective coating. Under the influence of moisture, rust products swelled and expanded, and cracks appeared in the protective coating [1].

Fig. 2. Rust of AN-2 seed drill

After that, the corrosive medium with atmospheric air reached the metal surface and carried out the corrosion process. Such preparation of metal surfaces always leads to such negative consequences. To prepare a rusty surface for protection, it needs to be perfectly cleaned of rust and other products.

Although the mechanical method of cleaning is laborious, it does not completely clean the rusty surface from debris [2].

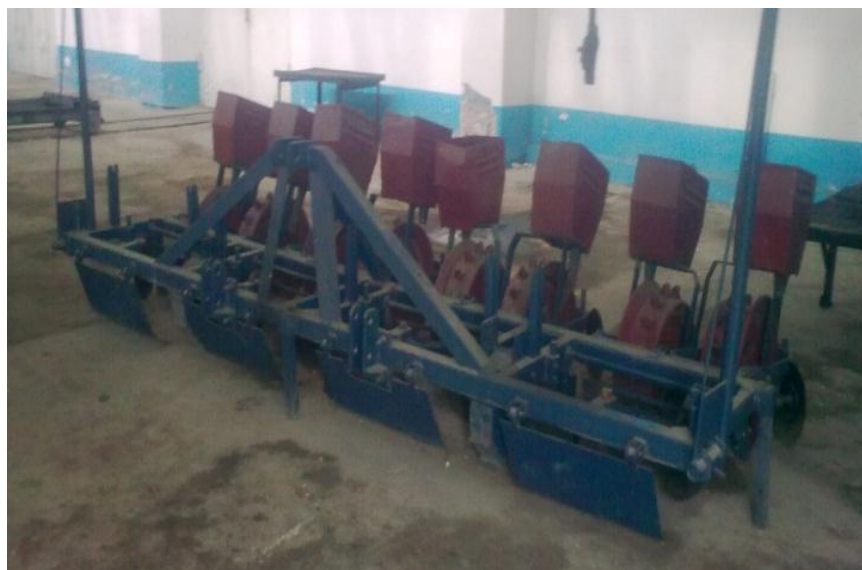
Fig. 3. Seeder for storage

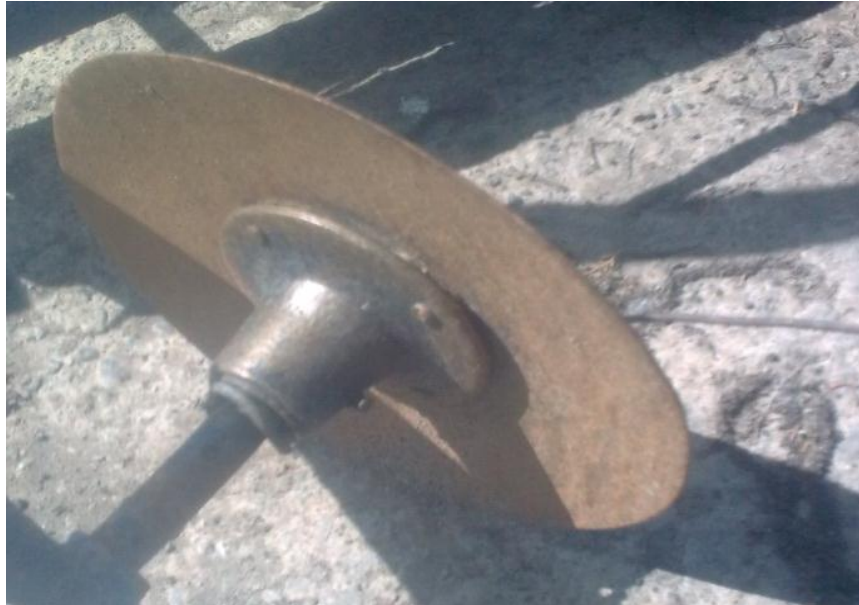
not been violated. The main reason for this is that the seedlings are washed at the required level in preparation for storage and thoroughly cleaned of various contaminants. When stored, rusted surfaces are treated with a rust modifier. In addition to neutralizing rust on the surface, the rust modifier has its inhibitory and barrier properties, and the integrity of the protective coatings is not compromised due to the use of promising means of protection. Machine-tractor park, the corrosion rate of the outer side of the sowing machine and the working bodies was 20-30 microns (see Figures 4-5) [3].

Fig. 4. AN-2 seed drill rust

Corrosion at this level does not preclude the fulfillment of the requirements imposed on the above working bodies. However, for a spring that ensures that the nesting organ opens and closes, a rust of this size will leave the nesting organ working without opening or closing, resulting in no seeds falling into the nest or a sharp increase in seed consumption. The reason is that the spring rusts and hardens.

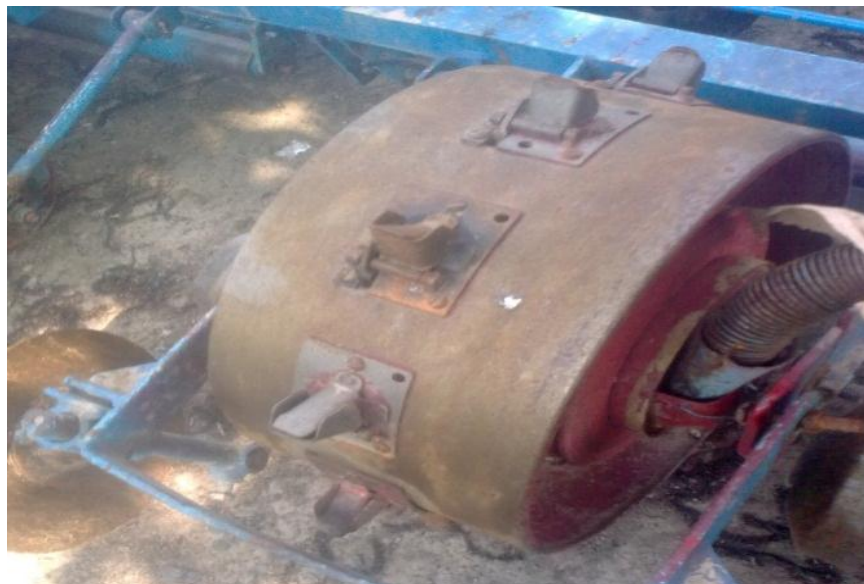
Fig. 5. Corrosion of AN-2 seed drill

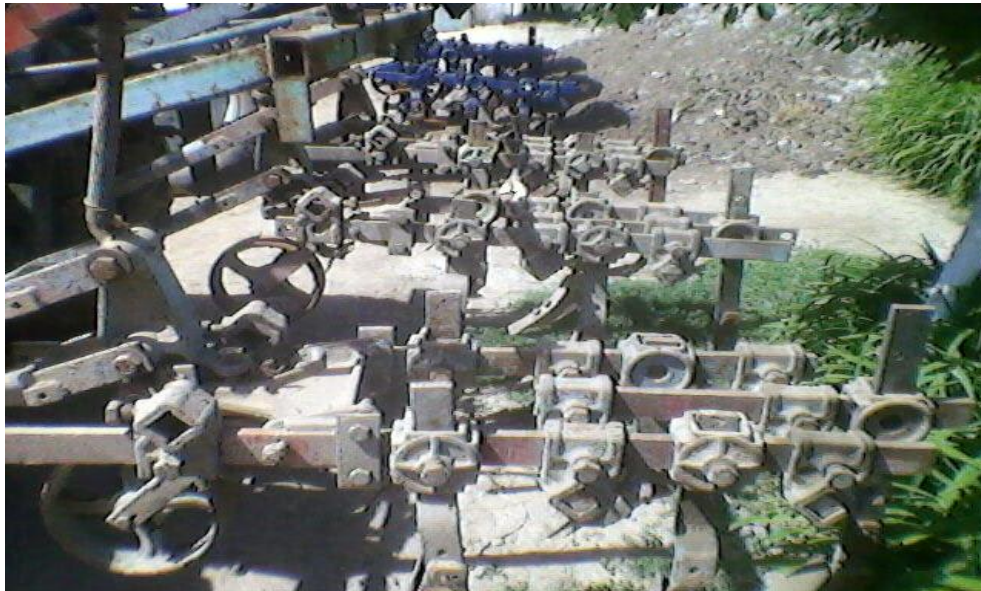
Fig. 6. Condition of KXU-4 cultivator

There were even cases when the cultivator was wrapped around the frames. During the operation of the cultivator, it was observed that its frames were touched by weeds, twisted and the protective coatings moved and rusted under the influence of aggressive environment. In such cases, the springs in the cultivator adjusting elements were replaced in some cases. The reason is that the elastic level of the spring is lost and it is unable to perform its intended function. That is, the working bodies cannot be adjusted after the loss of elasticity. The condition of the protective coatings of the cultivator after 17 days of use (see Figures 6-7) is shown. It was found that the integrity of the protective coatings on the corner parts of the cultivator frames was compromised and rust was forming under it. In addition, the rods on which the cultivator working bodies are fastened are rusted [5, 6].

In the sixth month of observations, 45 % of the protective coatings lost their integrity due to corrosion of the cultivator's frames. The springs from the adjusting elements of the cultivator's working bodies could not perform their function due to corrosion. Due to the rust product, the springs are stretched or stuck together [7].

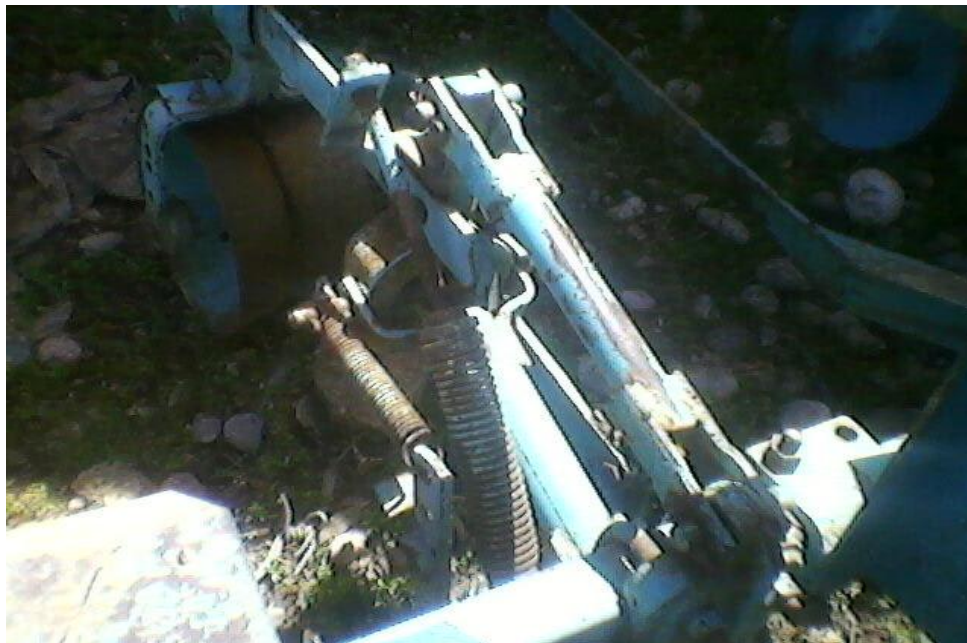
Fig. 7. Condition of KXU-4 cultivator adjustment part

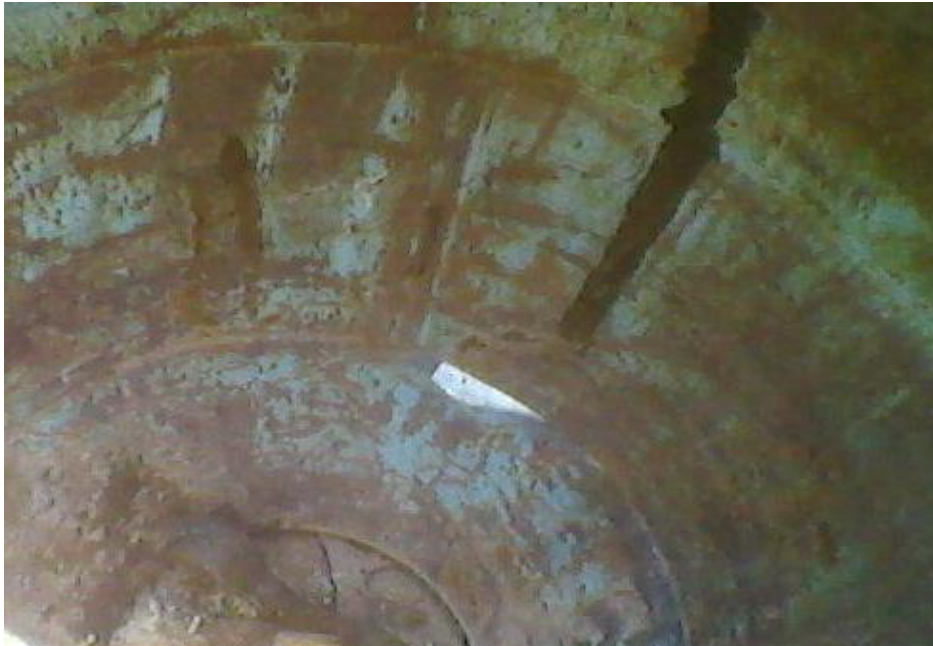
Fertilizer bunkers of cultivators put in storage by MTP were punctured after seven months by the protective coatings on their outer walls. This condition caused the metal to rust under the protective

coating and begin to move it. It was observed that the inner bottom of the bunker was corroded to 61-72 %, and the inner side walls to 82-88 % [8, 9, 10].

Fig. 8. Rusting of KXU-4 cultivator fertilizer hopper

In particular, the mineral fertilizer distribution plate at the bottom of the bunker is 100 % rusted (see Figure 8). When preparing the bunker for storage at this level of rust, it was not completely cleaned of mineral fertilizer residues and quality protective equipment was not used. It is also prepared for mechanical protection of rusty metal surfaces for laying protective means.
